STREET Talk

NORTHWEST CEMENT PRODUCERS GROUP

FEBRUARY 2008

Bellevue, WA. Ultra-Thin White Topping. A quick pavement fix that lasts!

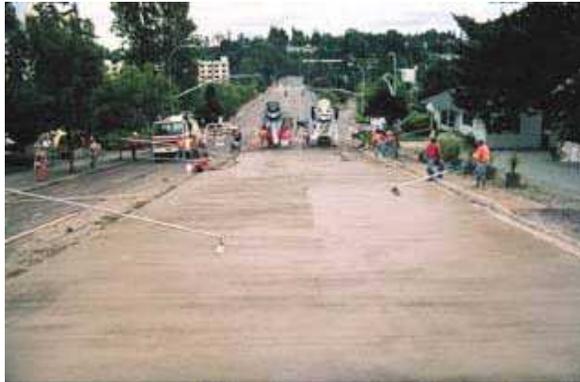
Figure 1. During construction, looking eastbound.

The 350-foot-long, 56-foot-wide test section is the first use of the process in Washington State, but is common in the Midwest. The city of Bellevue opted to use a three inch deep concrete section on top of a milled asphalt surface.

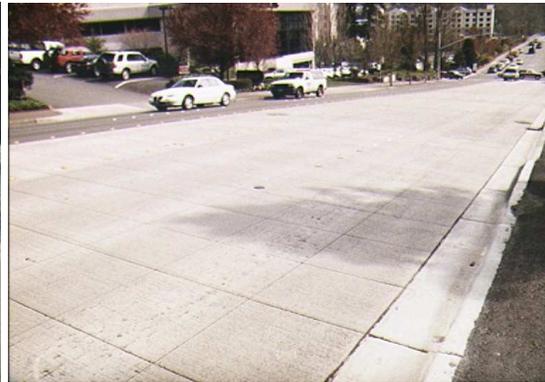
Figure 2. Completed pavement and curb detail, looking eastbound.

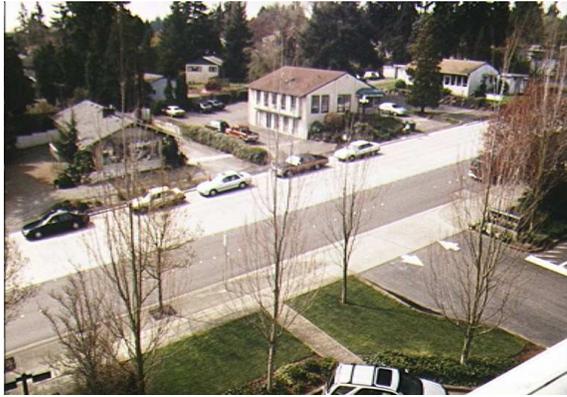
Figure 1. Rooftop view of the finished project, looking to the southwest.

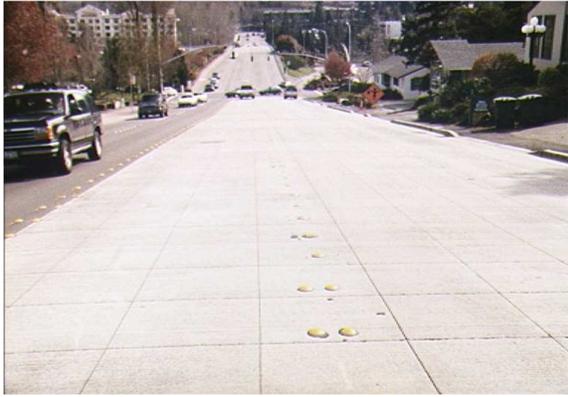
Figure 2. Finished project, looking eastbound.
